**Flood Control Project Maintenance
Levee Inspections**

Fall 2015 Levee Maintenance Deficiency Summary Report

San Joaquin River Basin

Reclamation District No. 0017 Mossdale

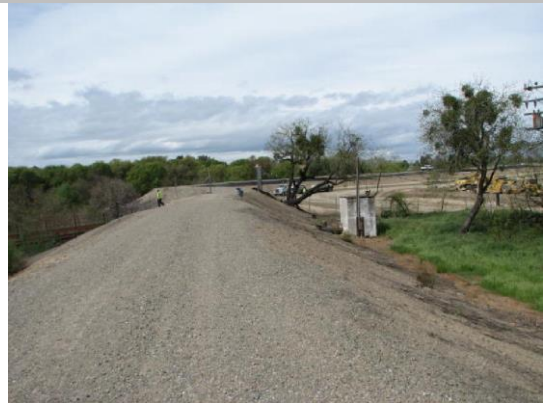
Photo 3 of 3 : UCIP_FA_2015_6328.jpg

Overview of levee crown at crossing.
